**POTENTIAL HAZARDOUS WASTE SITE
PRELIMINARY ASSESSMENT
PART 1 - SITE INFORMATION AND ASSESSMENT**

| 01 SITE NAME (Legal, common, or descriptive name of site) <u>Paxton II</u> | | 02 STREET, ROUTE NO., OR SPECIFIC LOCATION IDENTIFIER <u>116th St. & Stony Island Ave</u> | | | |

PRELIMINARY ASSESSMENT

FIELD PHOTOGRAPHY LOG SHEET

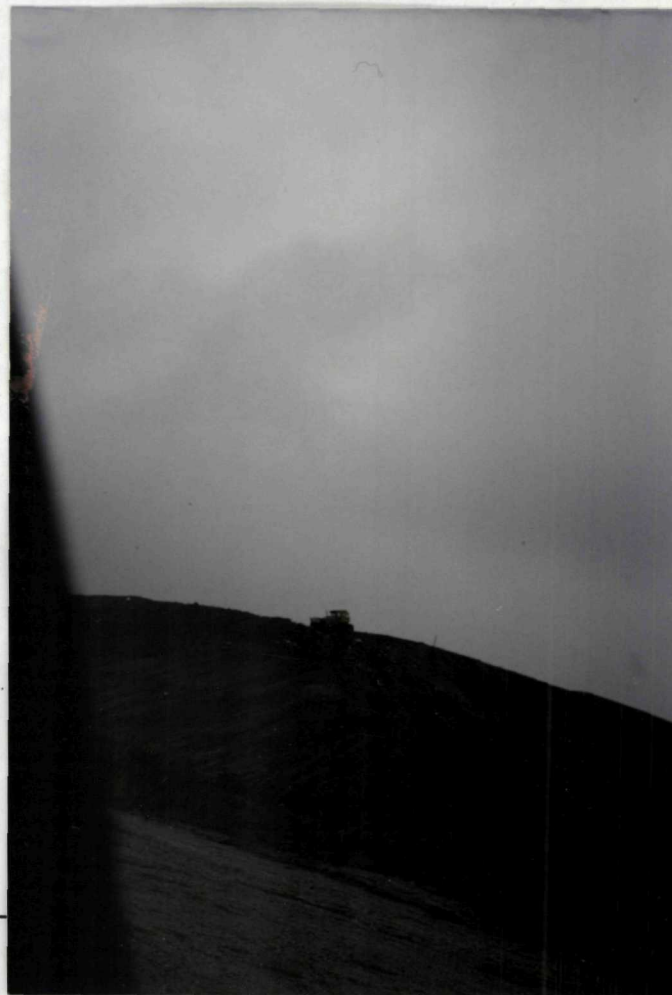
DESCRIPTION: active
refuse dumping

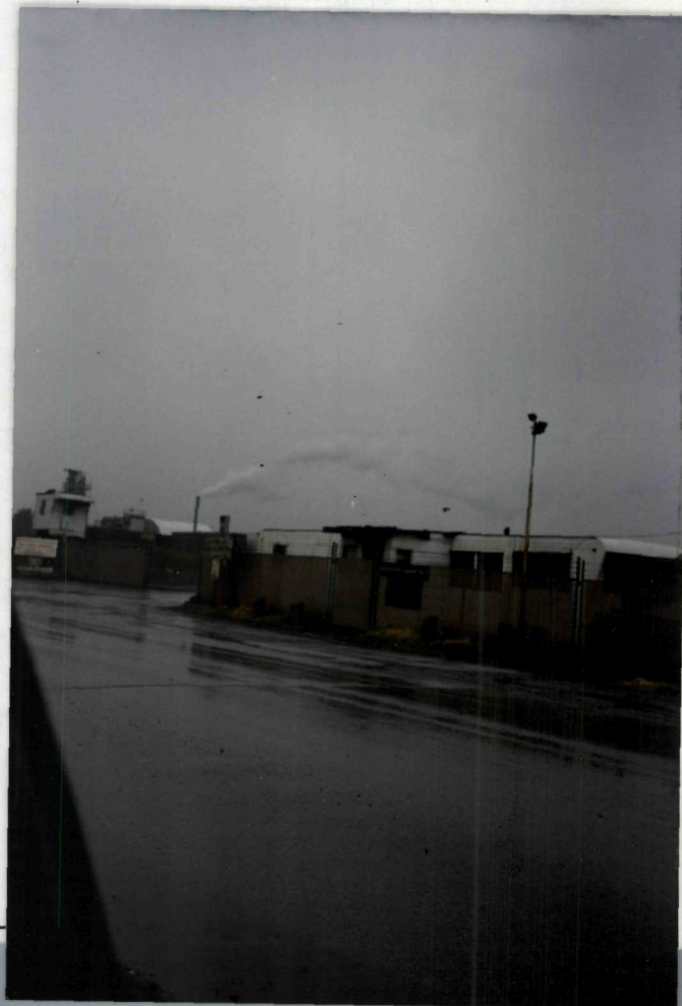
U.S. EPA ID: ILD069498186 TDD: F059104029PAN: FIL0030PADATE: 6/11/91TIME: 0905DIRECTION OF
PHOTOGRAPH: NWWEATHER
CONDITIONS: overcast ~70°FPHOTOGRAPHED BY: T. RamalySAMPLE ID
(if applicable): NADESCRIPTION: Paxton Landfill
entrance in foreground
and Paxton mobile
incinerator in background

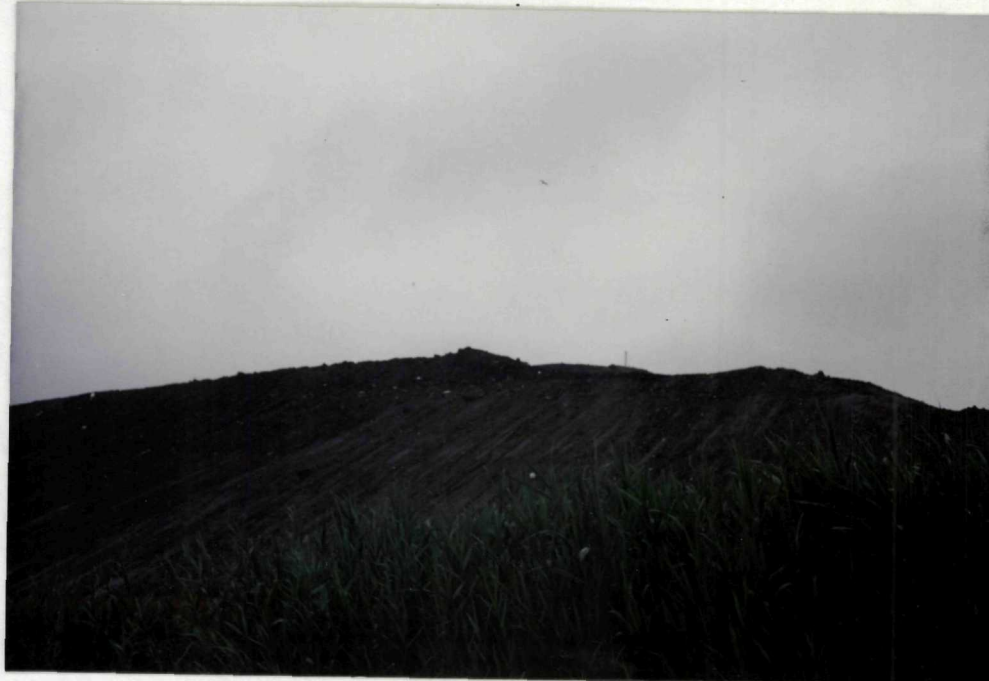
DESCRIPTION: uncovered area of Paxton landfill

showing exposed refuse

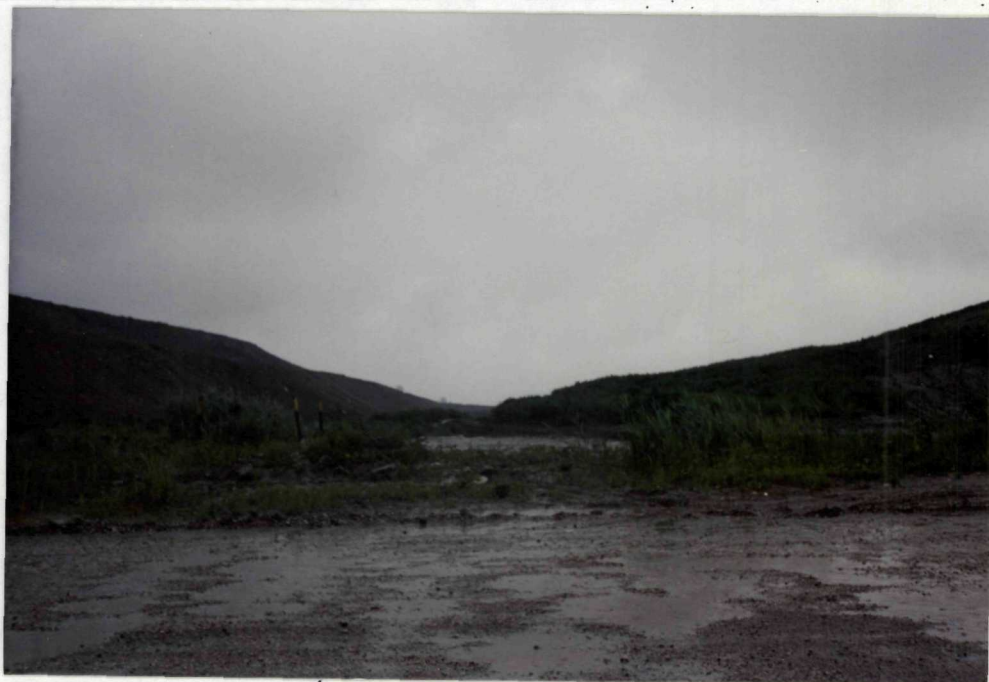
Surface water and leachate runoff is erratic and uncontrolled. There is a history of surface water runoff and leachate from the south slope of Paxton #II flowing across an access road onto the property of the Land and Lakes Company to the south. Here, a surface water drainage system of culverts channels the runoff under Stoney Island Road and into Lake Calumet. Lake Calumet is a fishery and is considered to be a sensitive environment. There also wetlands on-site which may support a federally endangered avian species, the Piping Plover, which nests in the site vicinity.

DESCRIPTION: drainage area between Paxton Landfill (left)

and Land+ Lakes #3 landfill-showing monitoring wells

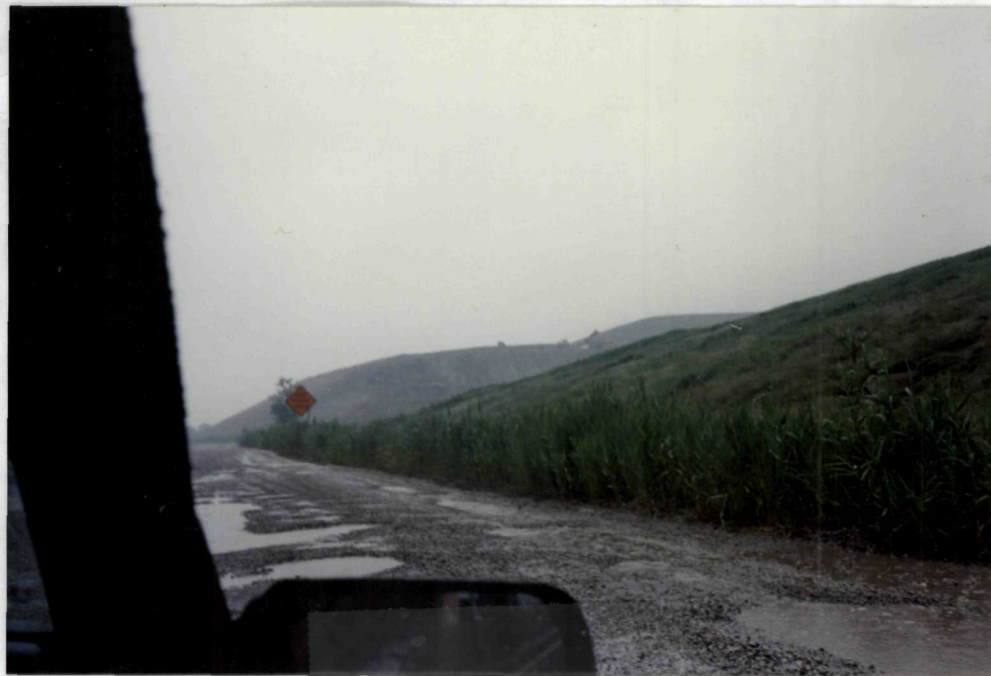
DESCRIPTION: > perspective photo showing Paxton Landfill
> in background and Land-Lakes #3 in foreground

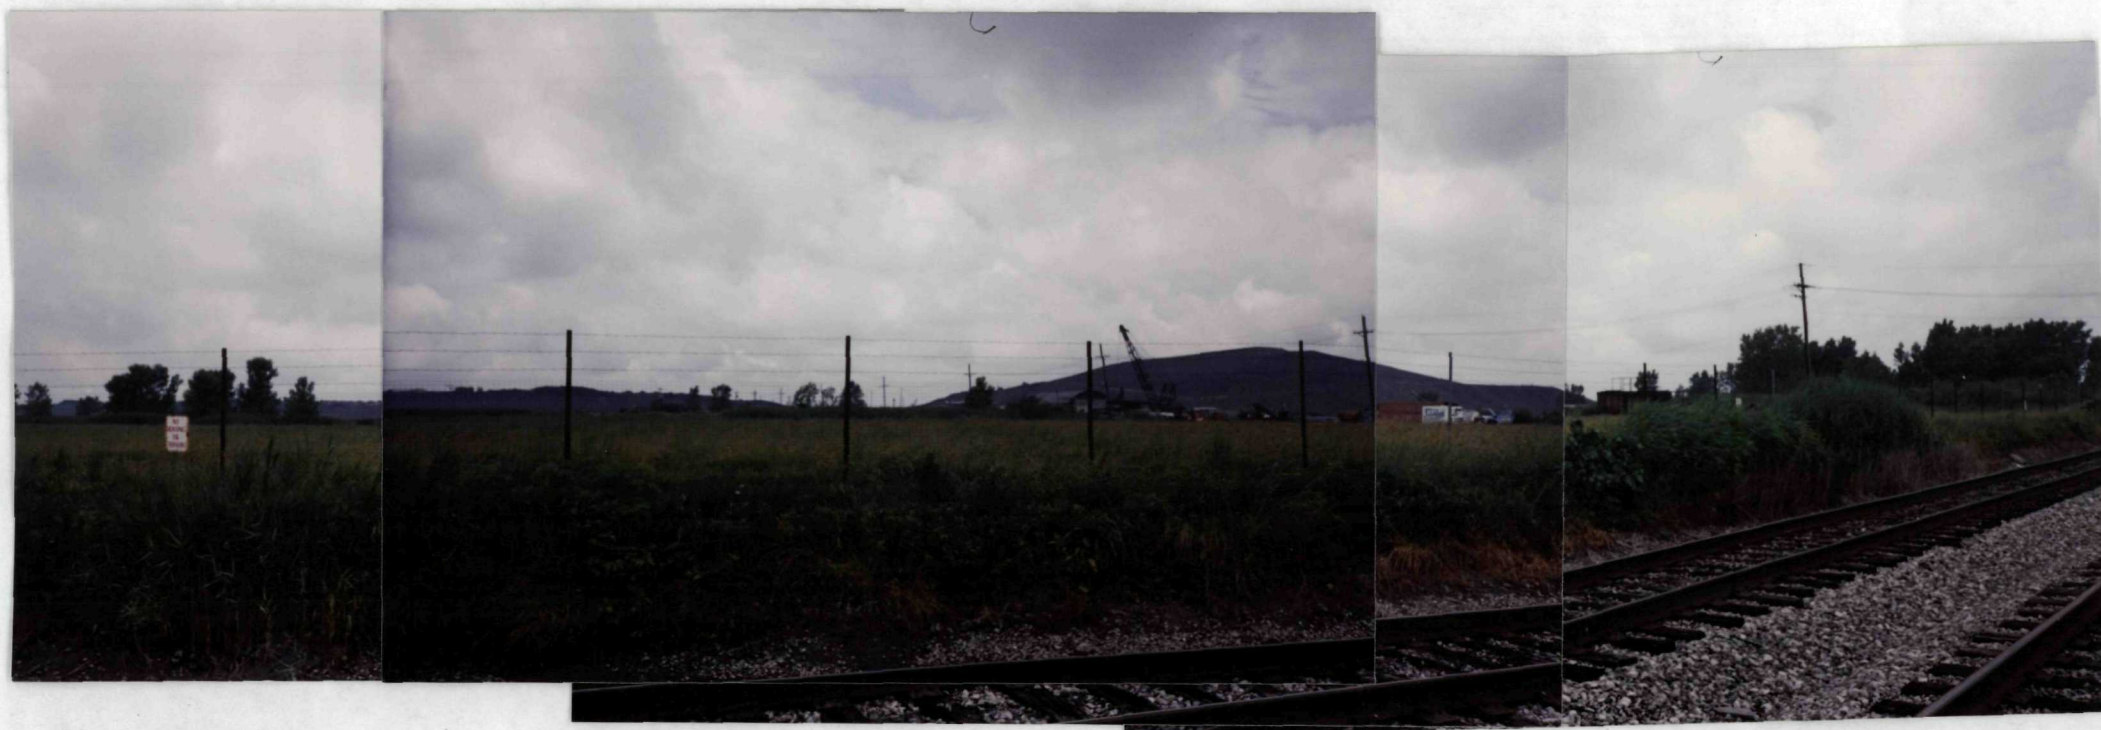
On June 11, 1991, Ecology and Environment, Inc. conducted an off-site reconnaissance. Paxton #I could not be seen from the road. Paxton #II was observed and noted to be without vegetation, active, and steeply sloped. No drainage system was evident on or at the base of the slopes which would prevent runoff from exiting the site.

DESCRIPTION: panoramic view of Paxton Landfill
